## Analysis of equipment life cycle at oil refinery

**K Y Kozhemyatov, Y A Bulauka**

**Abstract.** The results of the analysis of the service life of equipment operating under excess pressure at the Belarusian oil refinery are presented, directions for improving industrial safety when working with this type of equipment are proposed in this study. It was established that fittings with conditional passage up to DN100, the base metal and metal of the welds of the equipment body are the most wearing parts during the service life. Frequent replacement of fittings with a small conditional passage is connected with a small margin between the executive and rejection thicknesses of fittings' nozzles. The average service life of equipment operating under excessive pressure at the studied enterprise was established. **Keywords:** oil refinery, industrial safety, accident rate, equipment

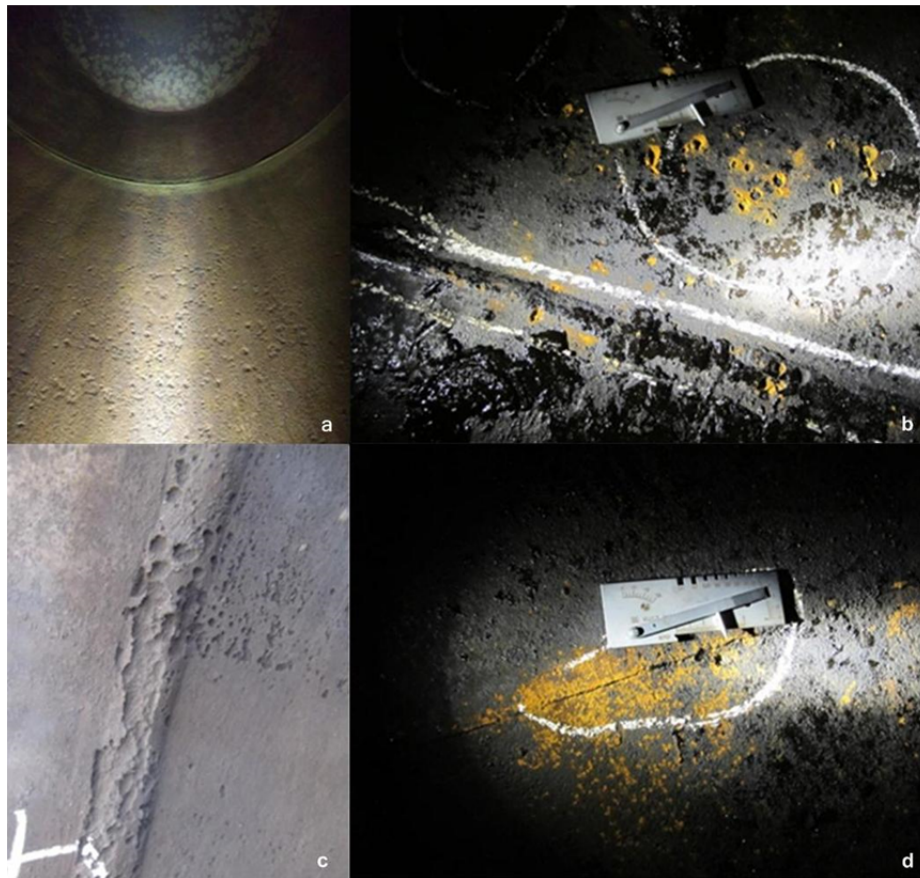
**Figure 1.** Corrosive wear out of base metal and weld metal (examples a, b, c, d).

*Vessels* make up 41% of the total number of studied equipment. According to TR CU 032/2013 vessels are hermetically closed containers (divided into fixed and mobile). This type of equipment is designed for conducting chemical, thermal and other technological processes, and also for the storage and transportation of gaseous, liquid and other substances. The replacement of nozzles with conditional passage up to DN100 (70% of the scope of work) has the highest frequency of repairs of vessels, 15% of the amount of work involved replacing nozzles with conditional passage of DN100 and more and repair of the base metal and metal of the body welds. Figure 1 (ex. a-d) shows examples of corrosive wear out of the base metal and metal of the weld seams of vessels on a research plant.

Comprehensive analysis of the life cycle of equipment operating under excessive pressure at the Belarusian oil refinery showed that nozzles with conditional passage up to DN100, base metal and metal of the body welds of various equipment are subject to a high risk of increased wear out during operation.

fittings with conditional passage up to DN100. At the same time, despite the slight increase in the cost of such equipment, it is possible to achieve maintenance-free operation of the equipment even after the end of the designated service life. The reasons for repairing the base metal and weld metal are hidden metallurgical defects and weld defects that were not detected during the manufacture of the vessel (apparatus), as well as the aggressive influence of the working medium of the vessel (apparatus), the formation of stagnant zones, the accumulation of solid particles from the working medium (scale, contamination, etc.), which are monitored visually and using ultrasonic thickness gauging. Ultrasonic and penetrant test can be additionally performed in places suspicious of defects. In our opinion, in order to minimize the number of repairs of this type, it is necessary to strengthen the incoming control for newly installed equipment. Also it is necessary to strengthen control over the selection of material for a specific working medium and operating parameters such as temperature and pressure and to ensure strict adherence to process regulations. For newly designed equipment employ modern technical solutions to minimize the number of stagnant zones.
